# **Inventory of Current Conditions and Land Uses**

## **Red Rock Road, Douglas County**

**Oregon Department of Environmental Quality  
and  
The Weyerhaeuser Company**

**June 2008**

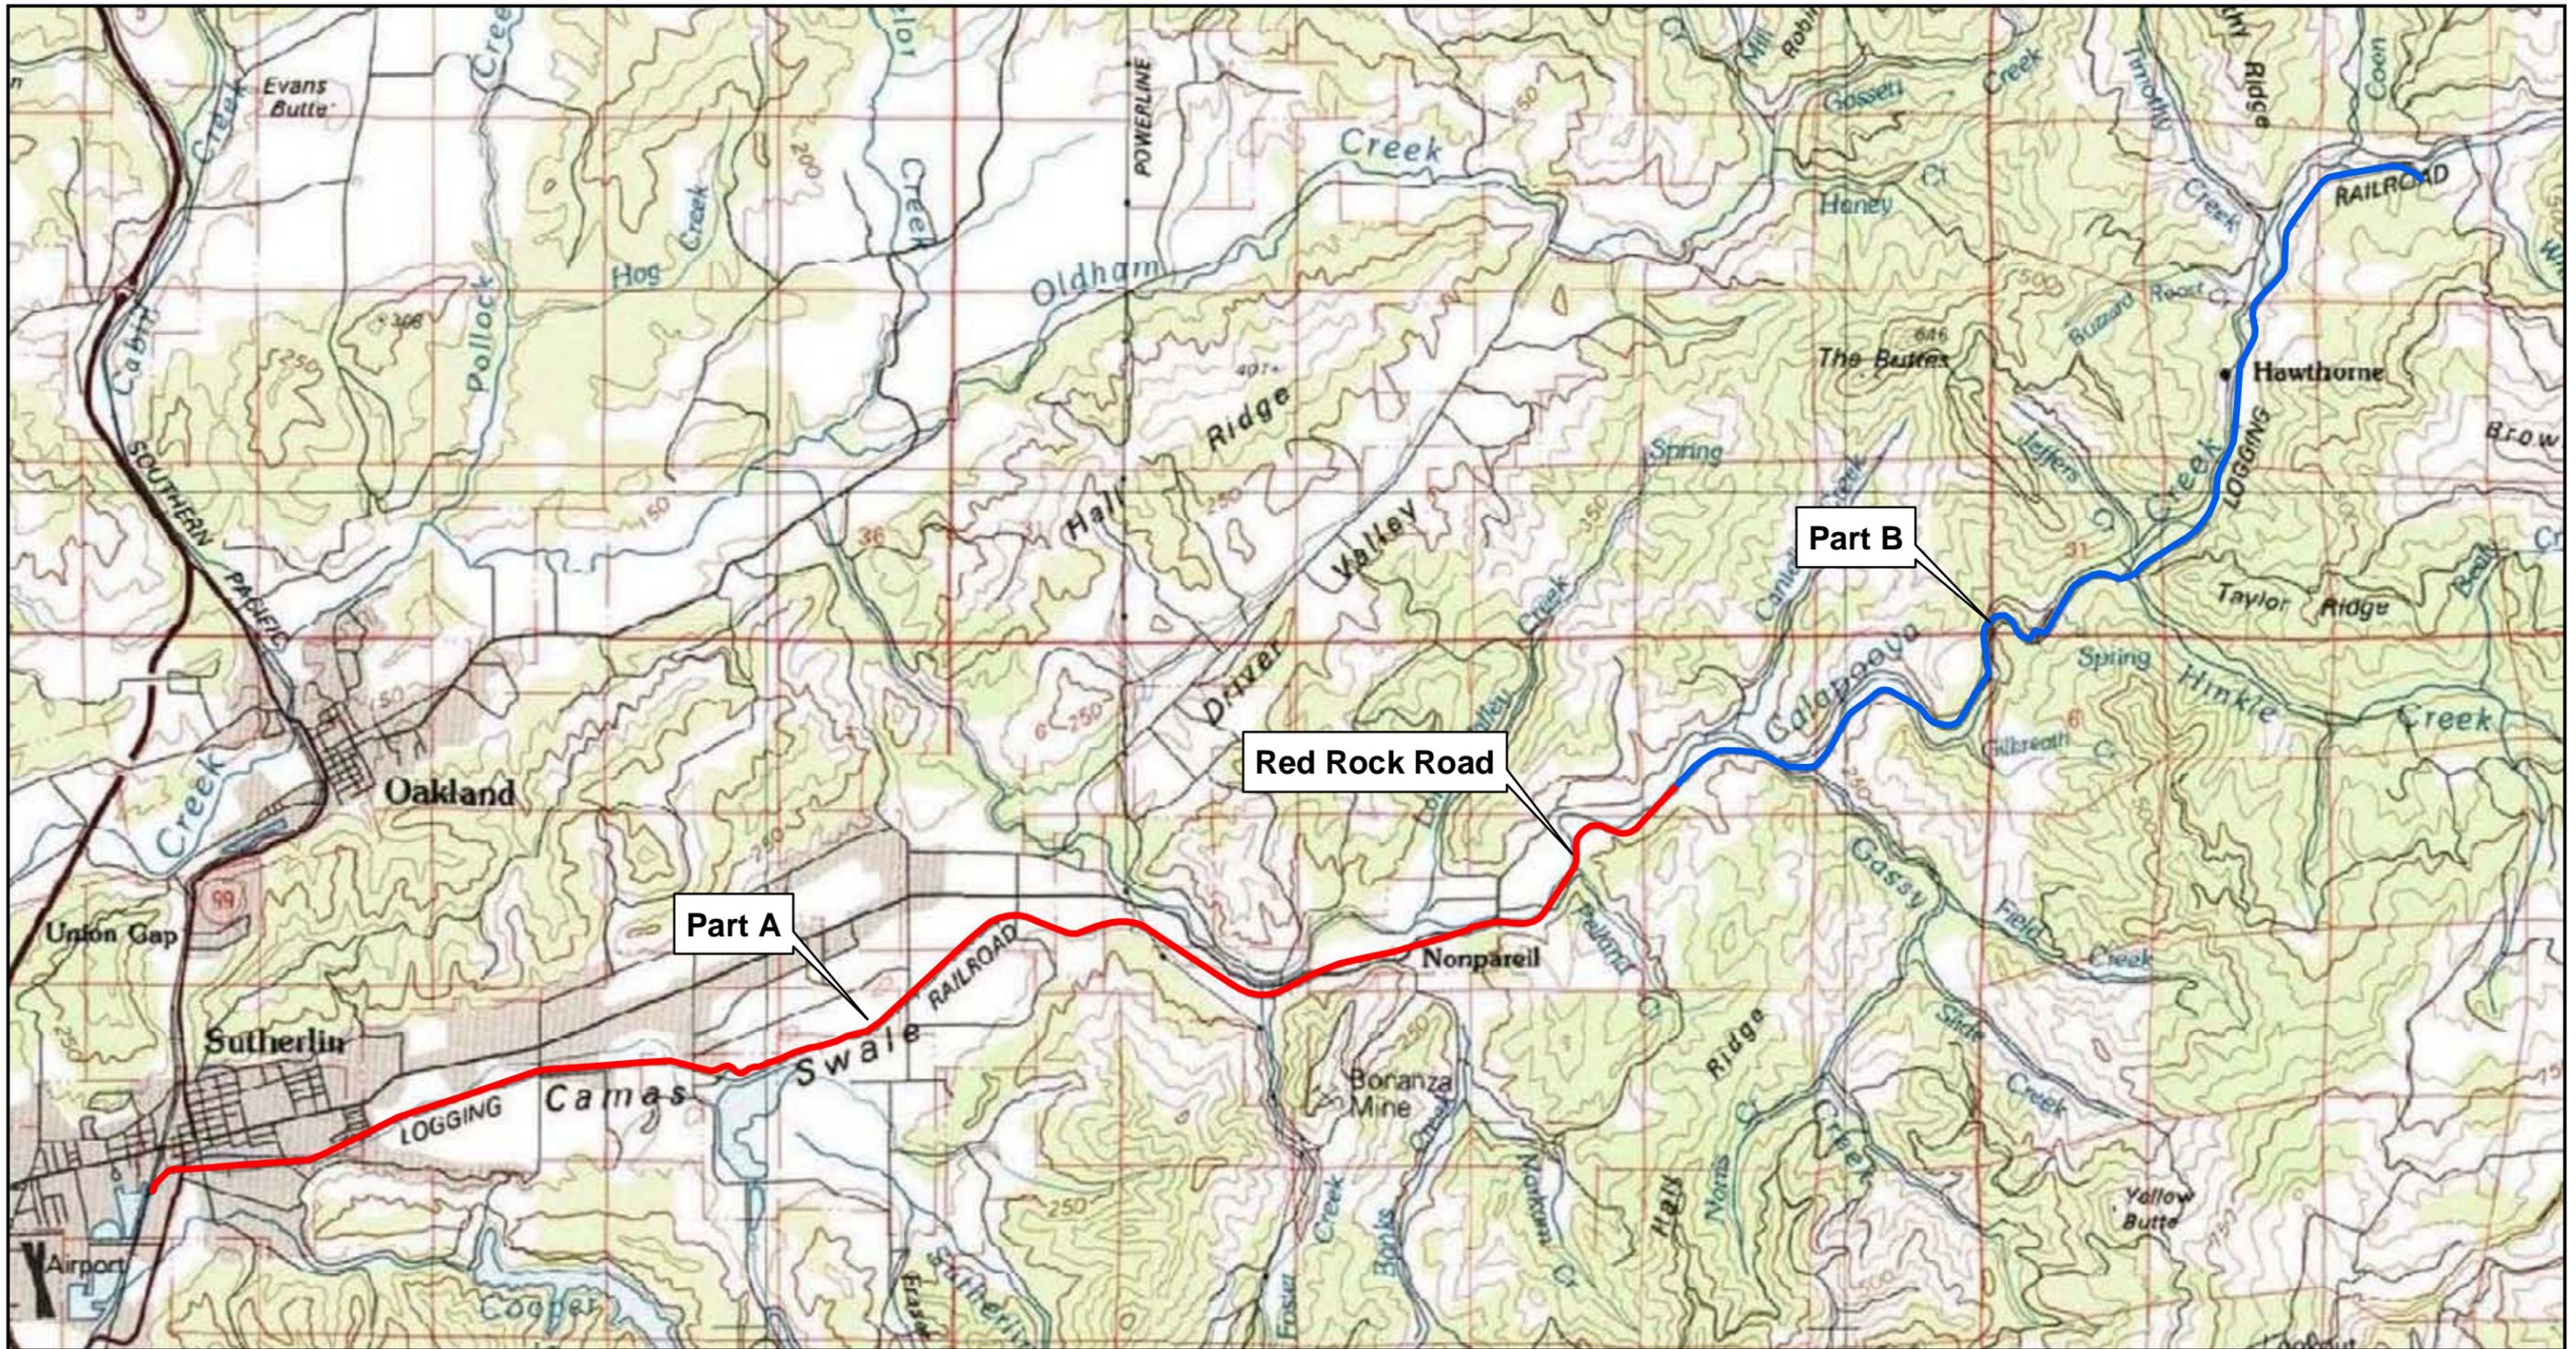
Figure 2  
**RED ROCK ROAD**

DEQ and Weyerhaeuser identified 12 properties where existing land uses and the presence of exposed tailings suggest that there is current potential for people to come into direct contact with arsenic from tailings in the RRR alignment at properties along the 17-mile alignment, as identified schematically on Figure 2.

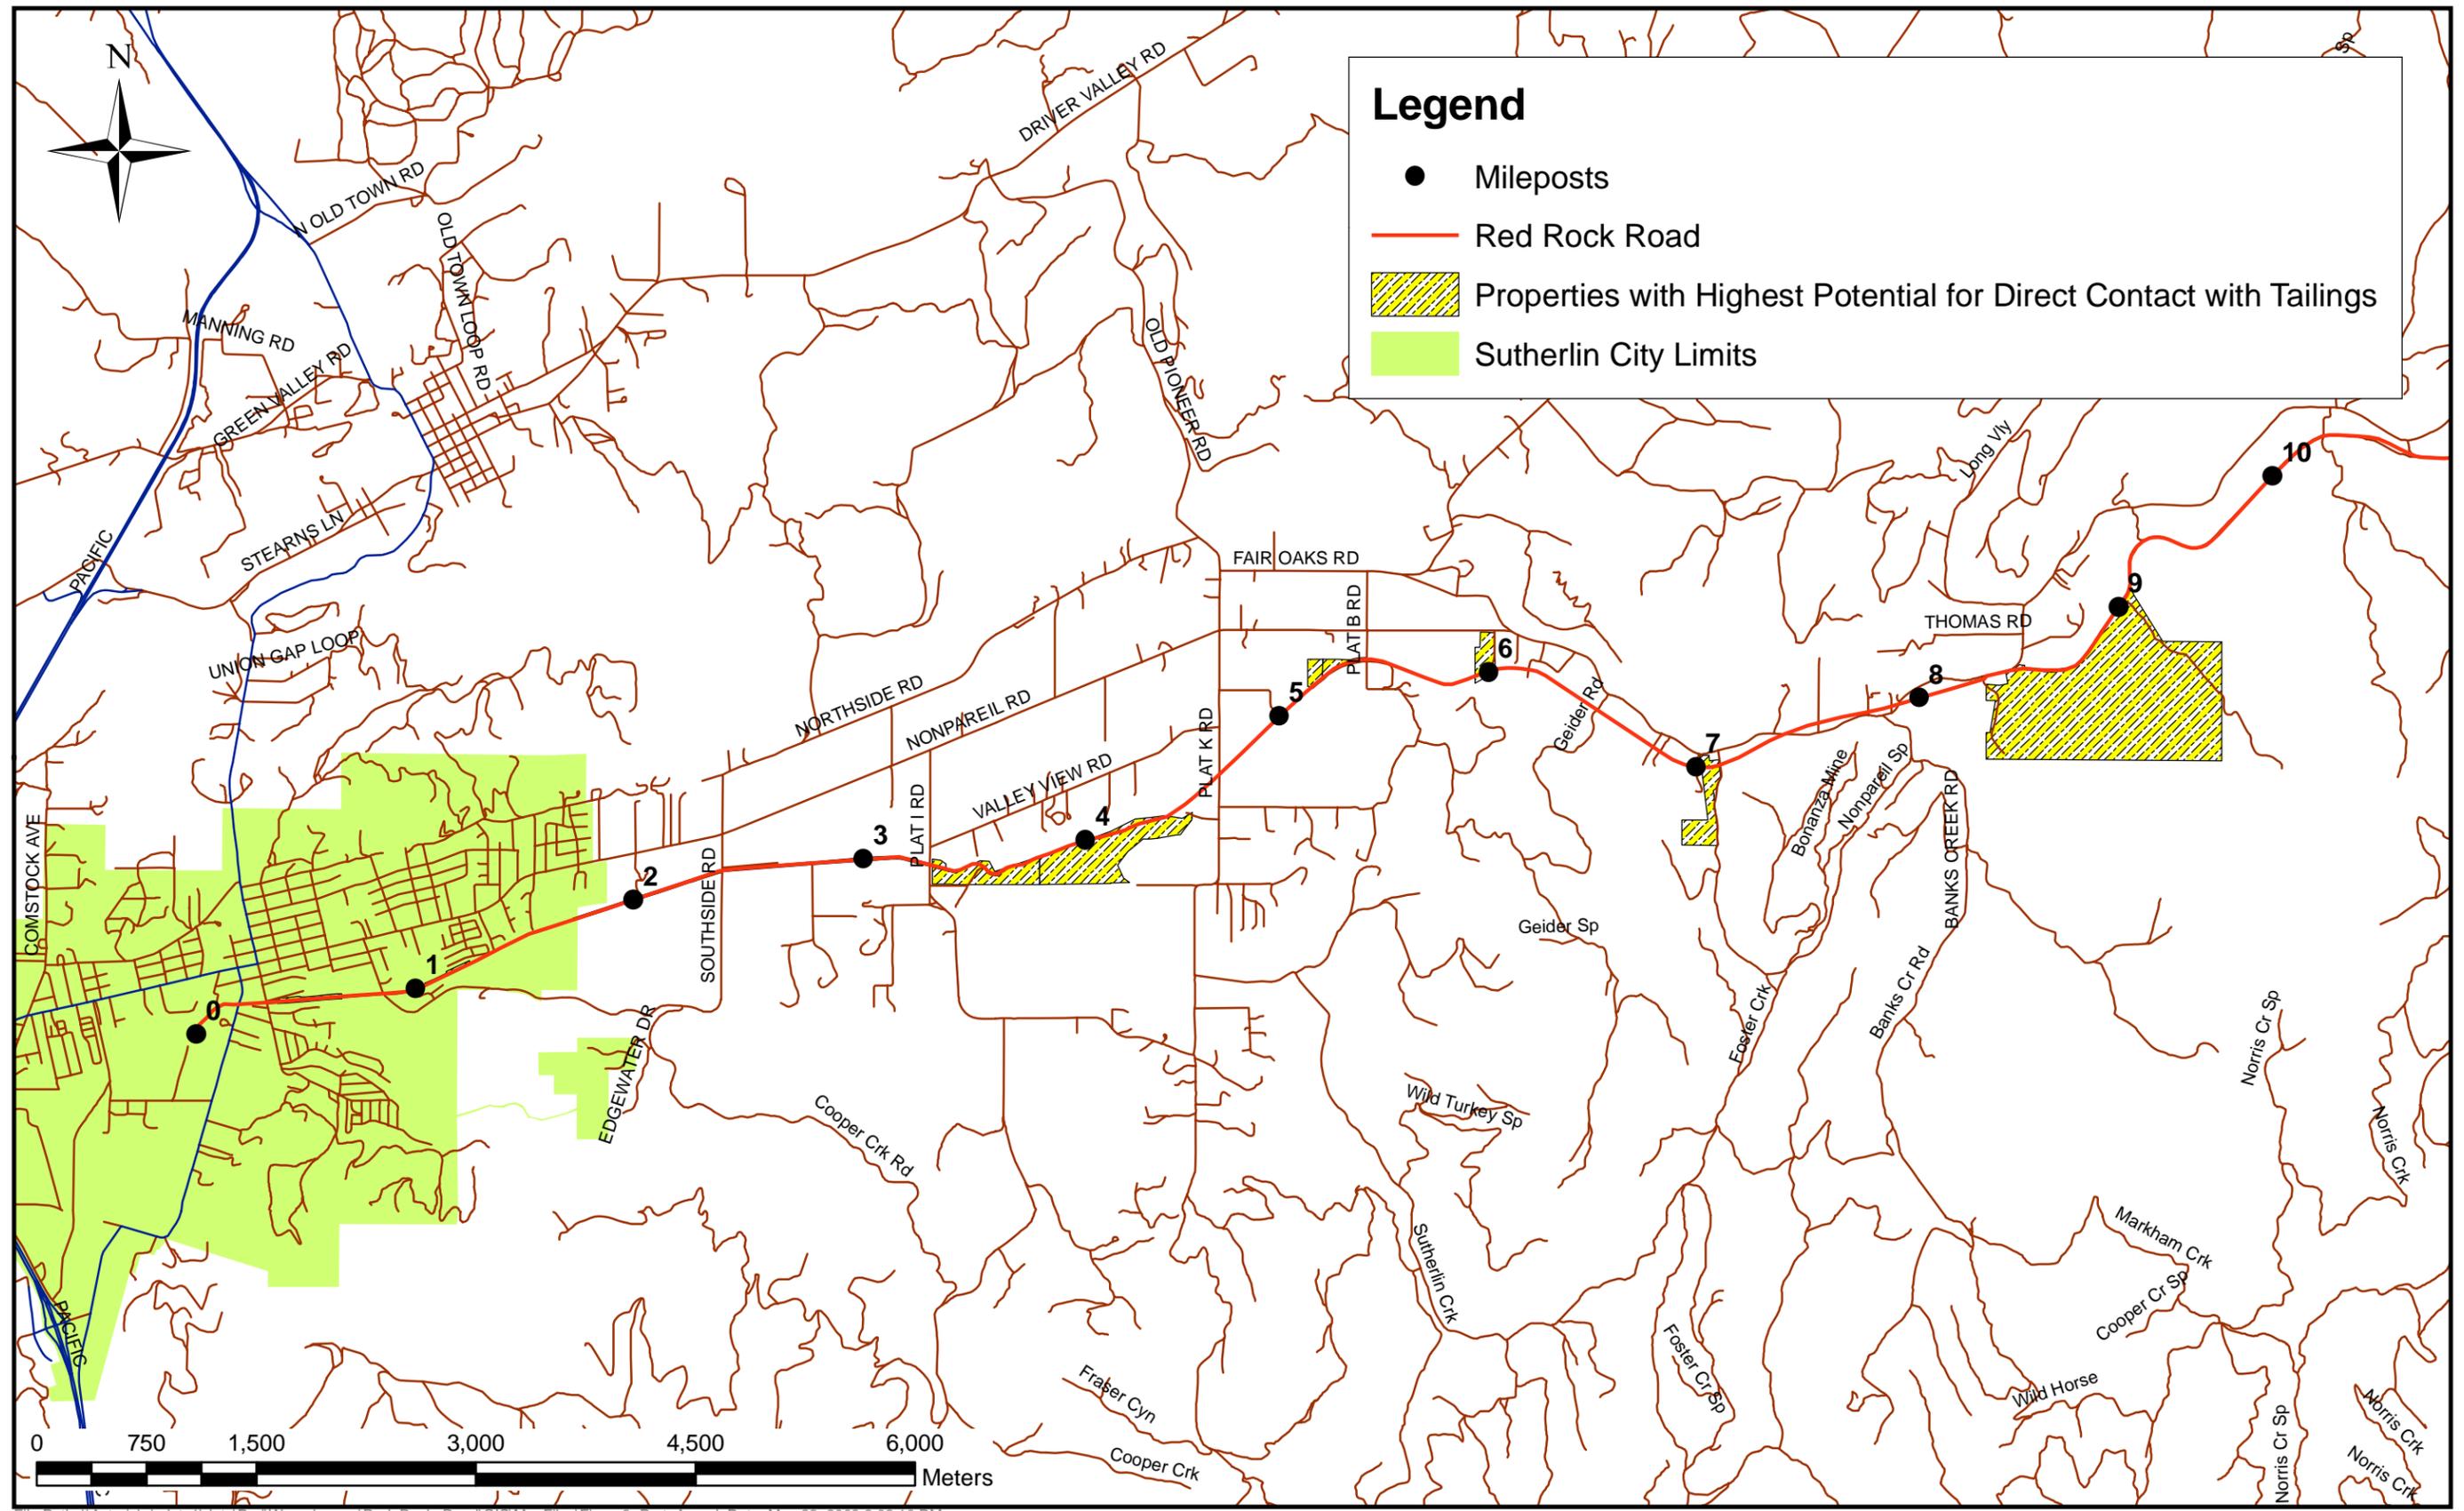
Figure 3  
Map of Part A  
Red Rock Road

Current conditions along the western 10 miles of RRR range from being remote, heavily vegetated, and inaccessible, to uncovered tailings exposed in a residential backyard. Beginning at the western end of RRR in Sutherlin, the first mile of the road is beneath industrial or residential properties where the typical covers are pavement, structures, or grass. Where there is no exposure of the tailings, there is no increased risk. There is no evidence of RRR under the residential properties along Azalea Court. Red Rock Road then becomes a City of Sutherlin right-of-way and continues east through residential neighborhoods, school property, and a park. In these areas, RRR is typically covered with grass and has localized tailings exposed in more traveled areas. Many of the residents' backyards abut RRR.

Past the residential neighborhood RRR continues into residential or agricultural properties, where it is mostly used for farming access. This continues until RRR crosses Nonpareil Road, about halfway past the seventh mile. For the next half-mile, RRR continues through residential properties, where the condition of RRR is highly

The last section of RRR, from miles 8 through 10, continues mostly through residential and agricultural properties. The condition of RRR through this area ranges from having a vegetative cover with two uncovered tracks made by farm vehicles, to having no cover and exposed tailings. Property M93347 uses an exposed section of RRR as their driveway.

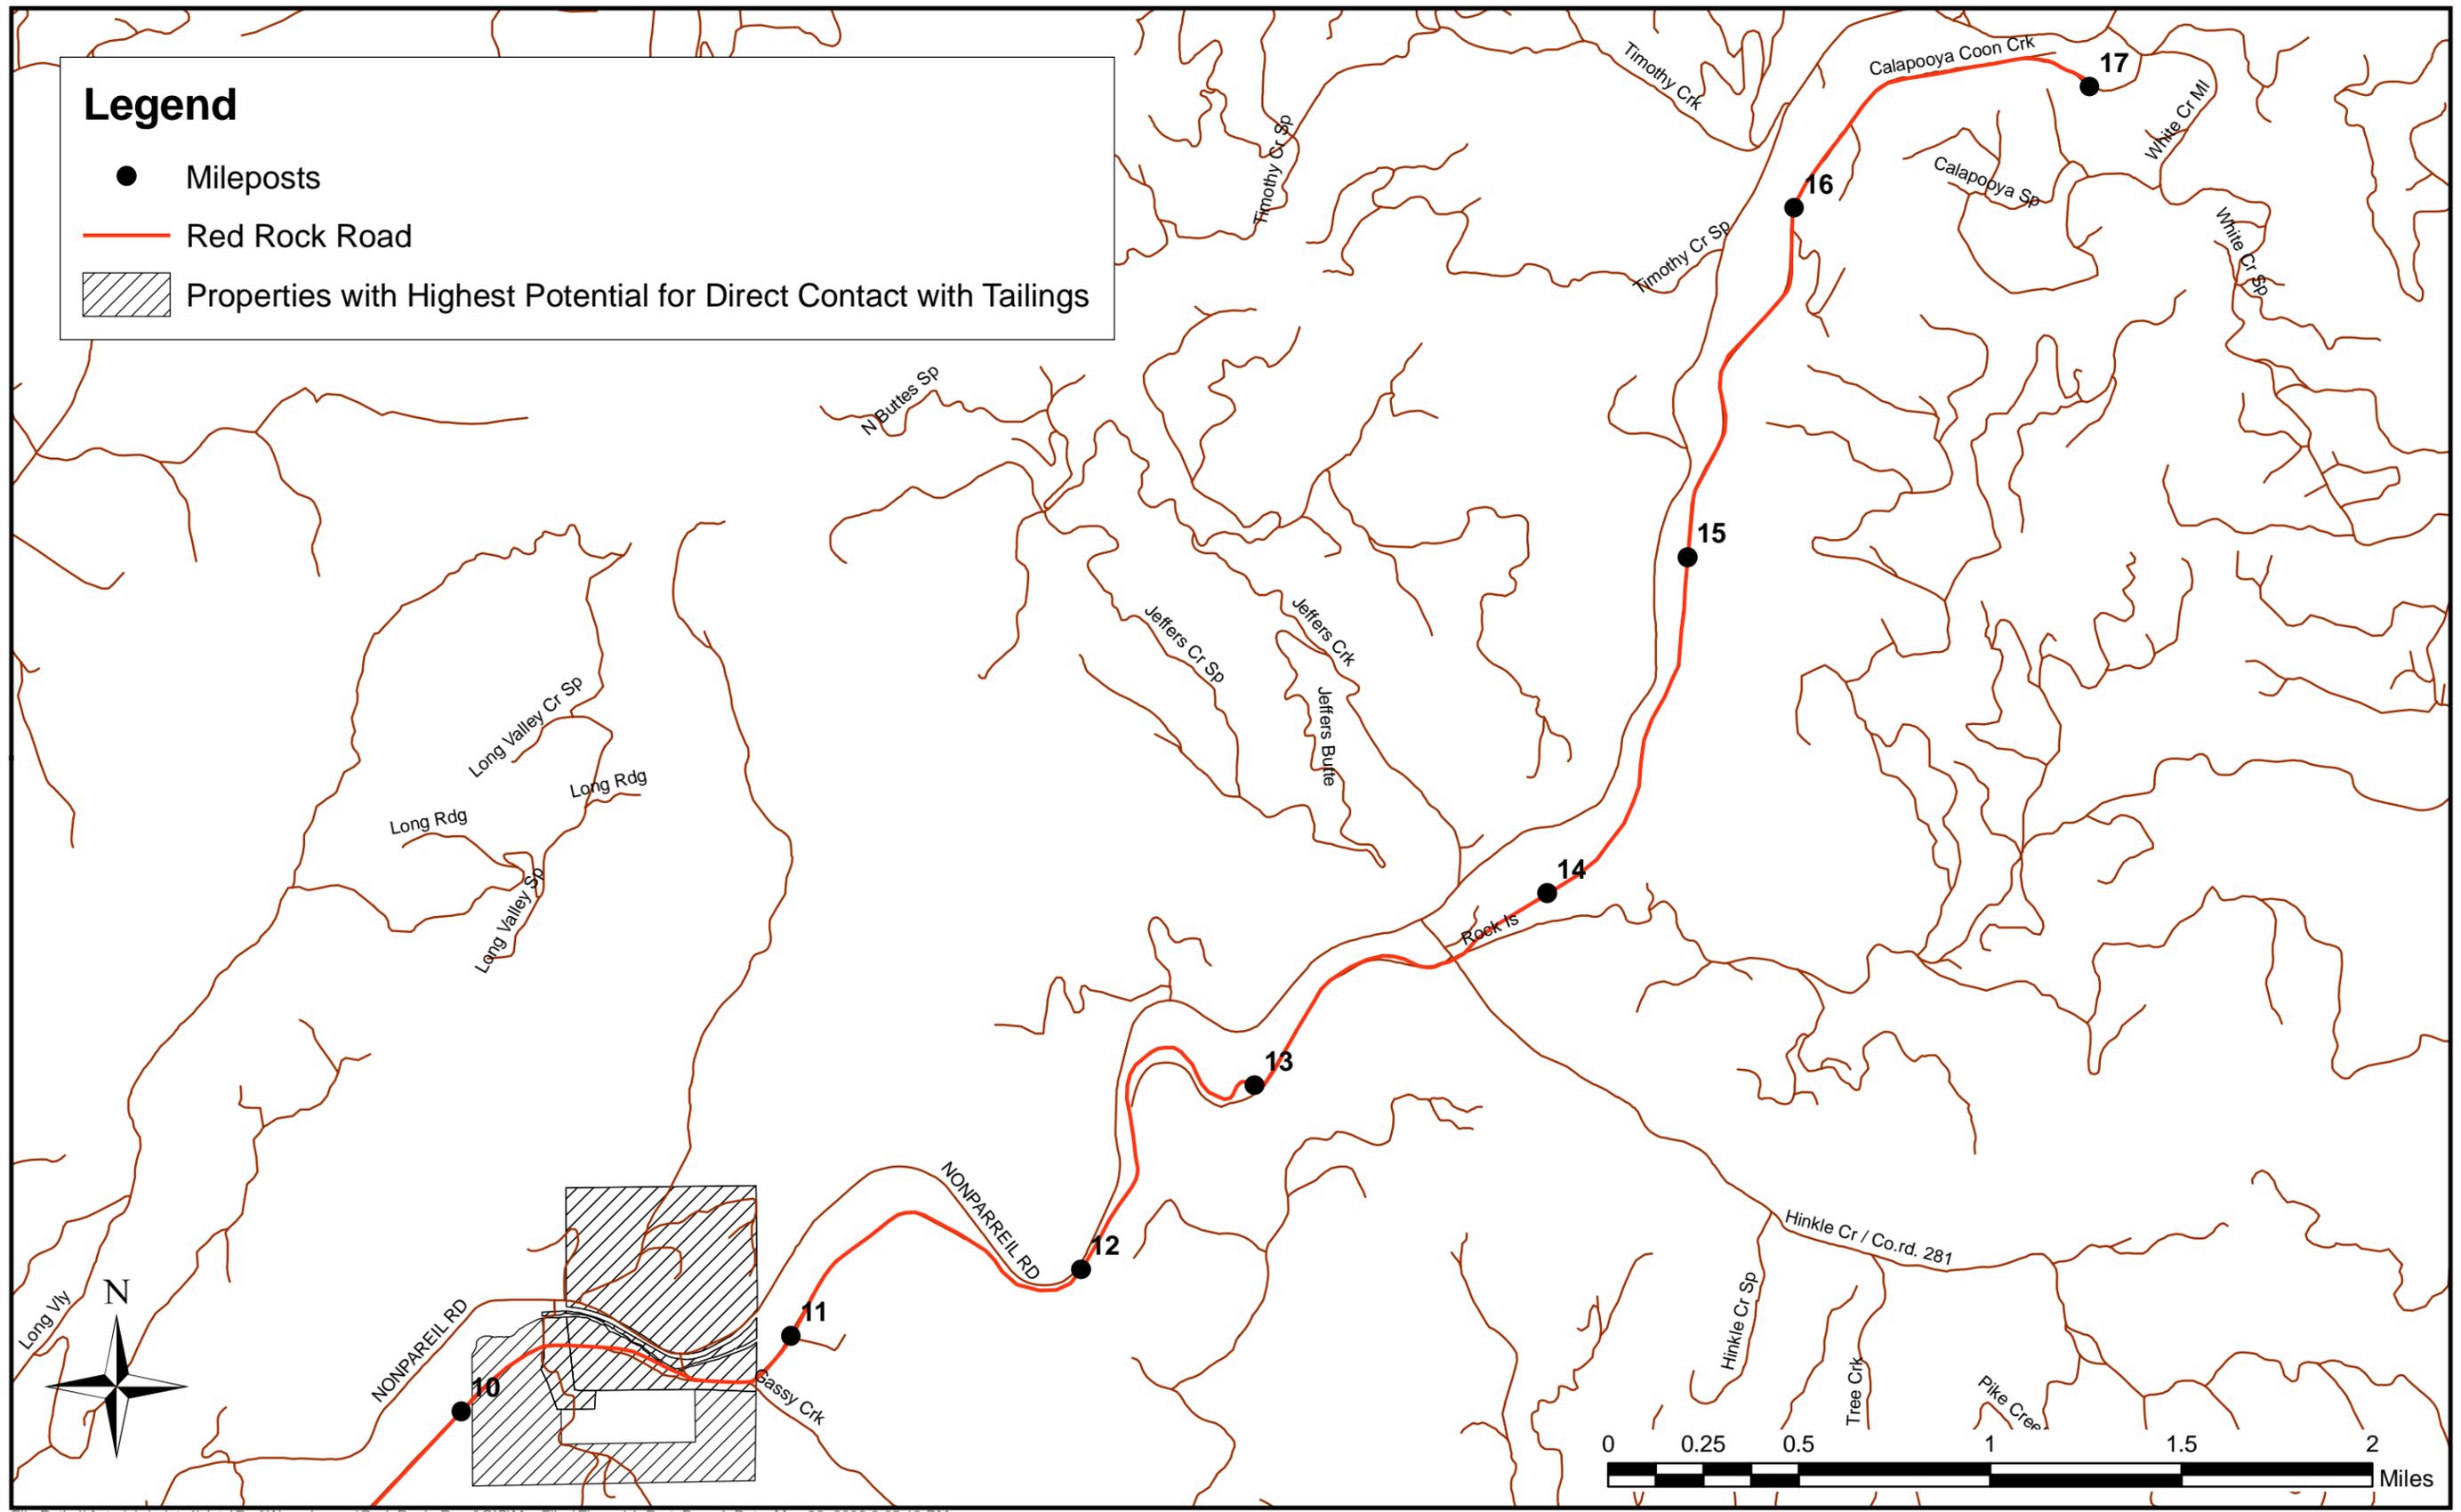
Figure 14  
Map of Part B  
Red Rock Road

The following section describes the current condition of the eastern 7 miles (miles 10 to 17) of RRR based on the December 13, 2007 field survey (Figure 14). The general condition of RRR is summarized for each mile section of RRR. Further details on parcels that have the potential for human exposure to RRR tailings or soils based on accessibility and the potential for direct contact are provided. Inventory results are summarized in Table 2.
